TECHNICAL REPORT GL-81-2

15 MILE ROAD/EDISON CORRIDOR SEWER TUNNEL FAILURE STUDY DETROIT AREA, MICHIGAN

Geotechnical Laboratory
U. S. Army Engineer Waterways Experiment Station
P. O. Box 631, Vicksburg, Miss. 39180

January 1981

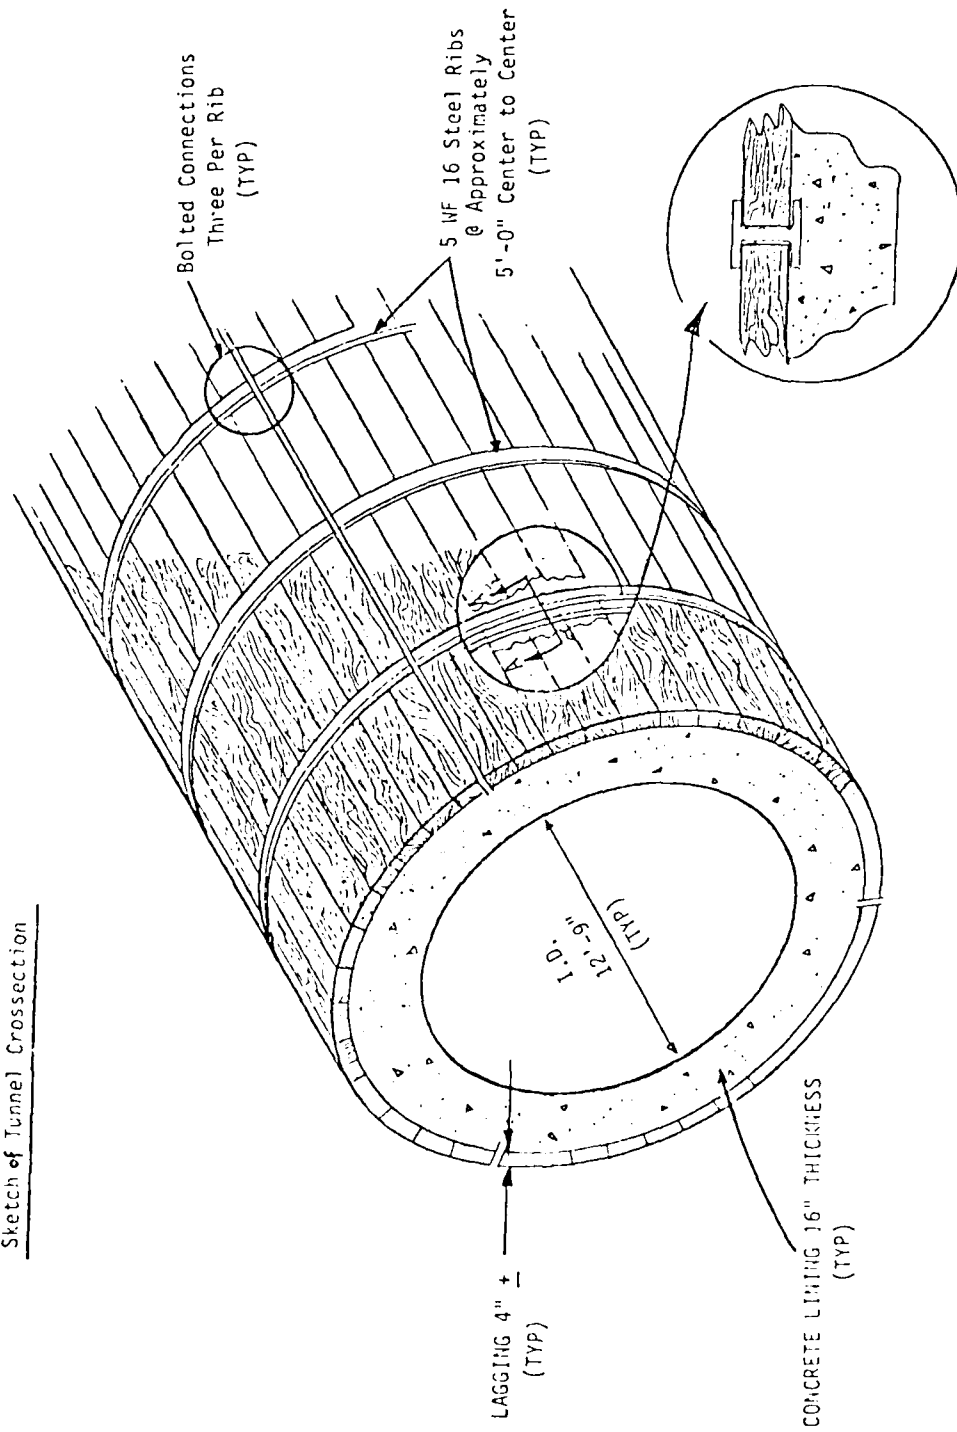
Figure 2. Tunnel cross section

12. The design for this sewer tunnel was prepared by the City of Detroit and is discussed in more detail later in this report. The design assumed that the tunnel would be uniformly loaded externally and be in perfect ring compression. The surrounding soil was assumed to have no shear strength. The concrete wall thickness was a function of the soil cover to the springline and the inside diameter of the tunnel. The compressive strength of the concrete, using these design assumptions, had a safety factor of about 7. For this tunnel, the inside diameter was specified to be 12 ft 9 in. and the wall thickness 16 in. The required concrete compressive strength, f_c , was computed to be 482 psi.

13. The contractor constructed this sewer by boring a circular tunnel with a mining machine and holding the soil in place with steel ribs and wood lagging (see Figure 2, Tunnel Cross Section). Steel forms were centered in the ribs and lagging of the primary lining, and concrete was dropped from the ground surface through baffled pipes to place the concrete lining. Generally, the concrete placements for the lining were 105 ft long. Keyways were formed at the construction joint for each concrete placement. The tunnel design did not provide for any steel reinforcing; however, when the concrete wall thickness was between 15 in. and 12 in., reinforcing was required. Thicknesses less than 12 in. were not allowed and re-mining was required to provide minimum wall thickness. The contractor sank deep wells to dewater the project

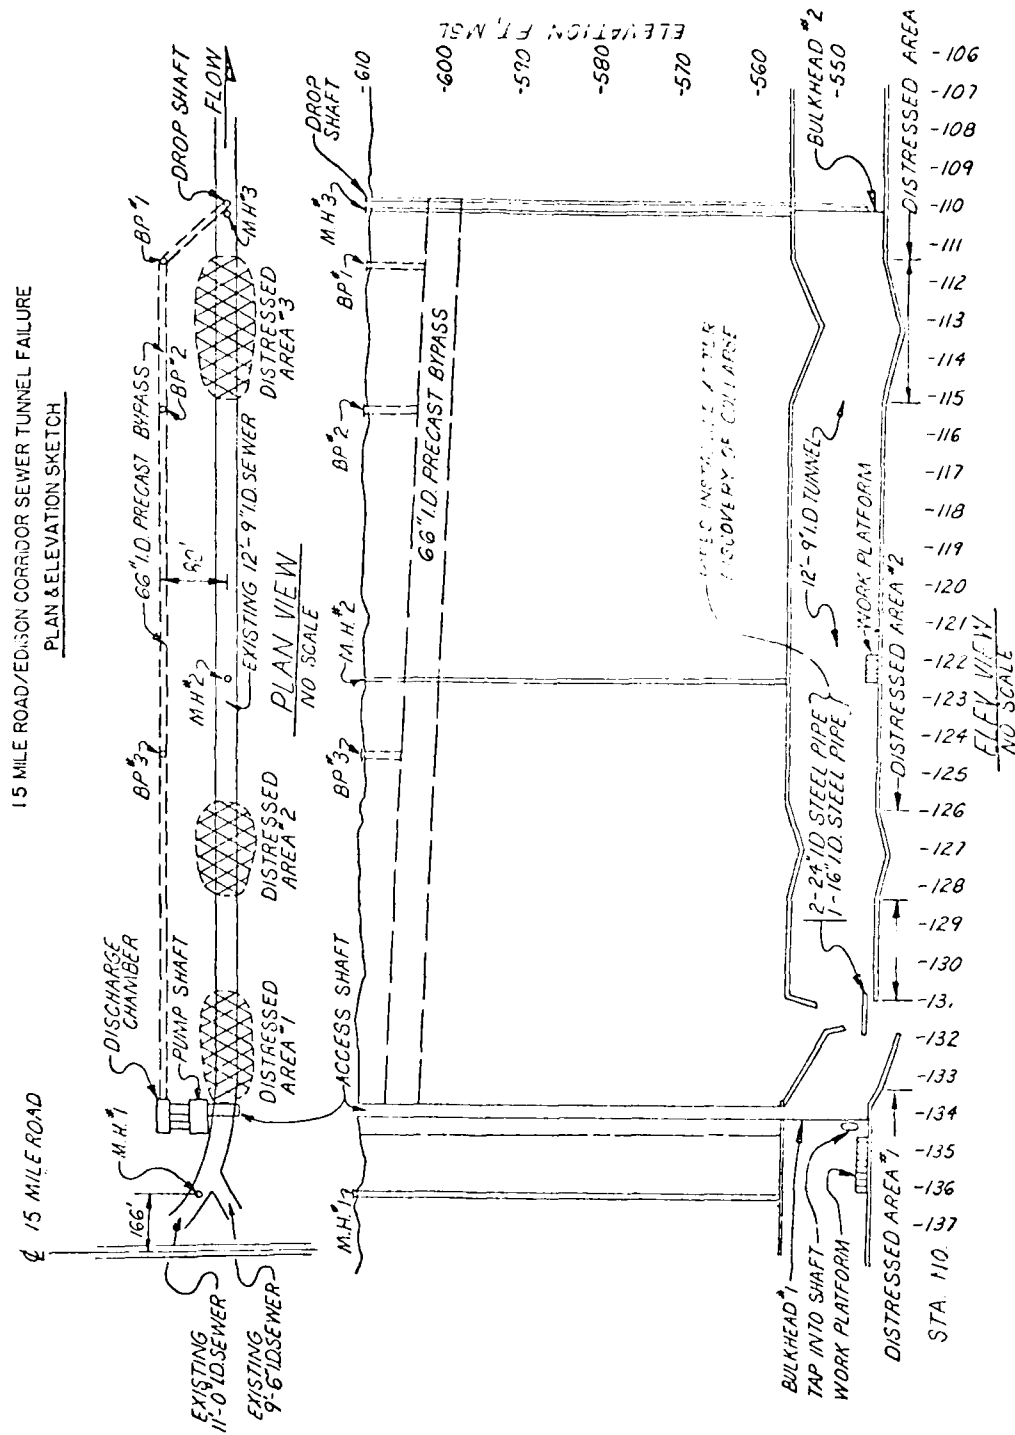
Figure 3. Tunnel plan and elevation sketch

15. On 27 January 1980 the Detroit Water and Sewerage Department (DWSD) sewer safety crew performed an inspection of Contract PCI-7. The crew entered the tunnel through a manhole just south of 15 Mile Road, walked one mile southward, and exited from a manhole south of the center line of 14 Mile Road. It was during this inspection that the three distressed areas in the sewer tunnel were discovered (see Figure 3, Tunnel Plan and Elevation Sketch). No record of an inspection between 1972 and 1980 was found.

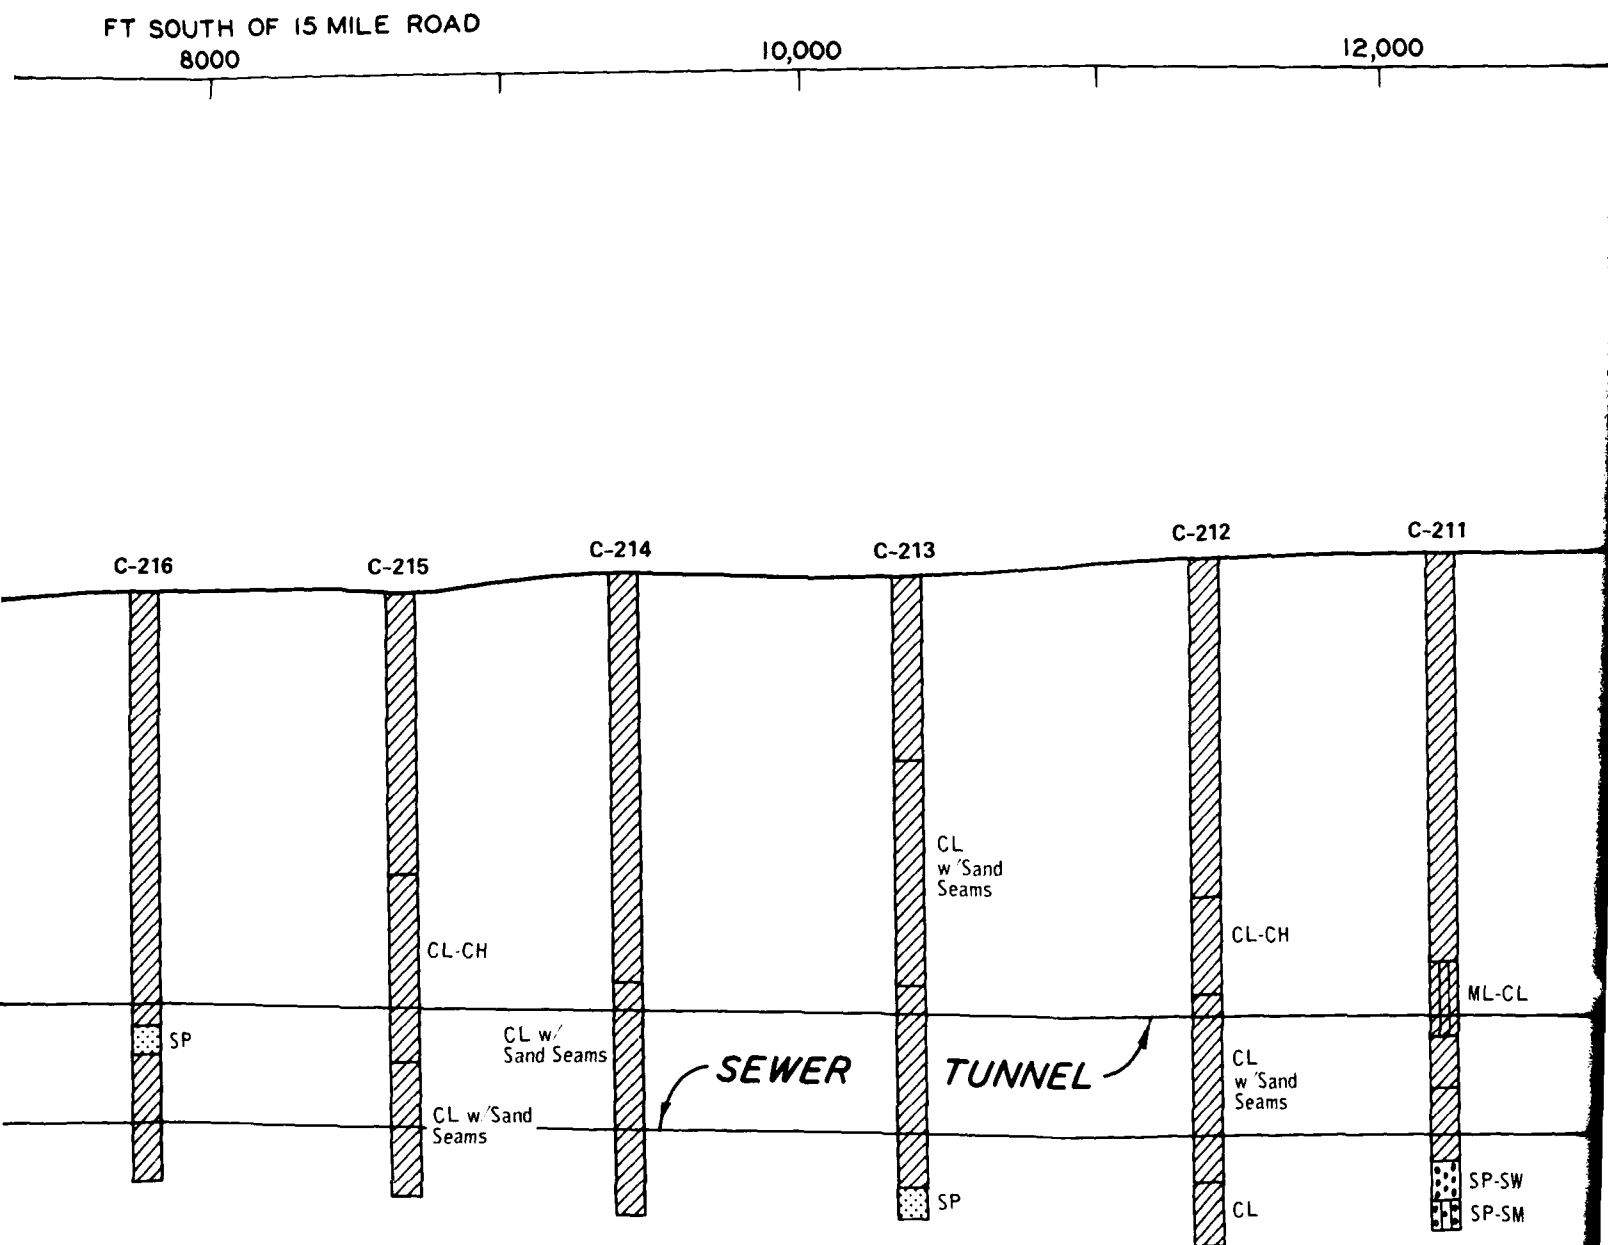
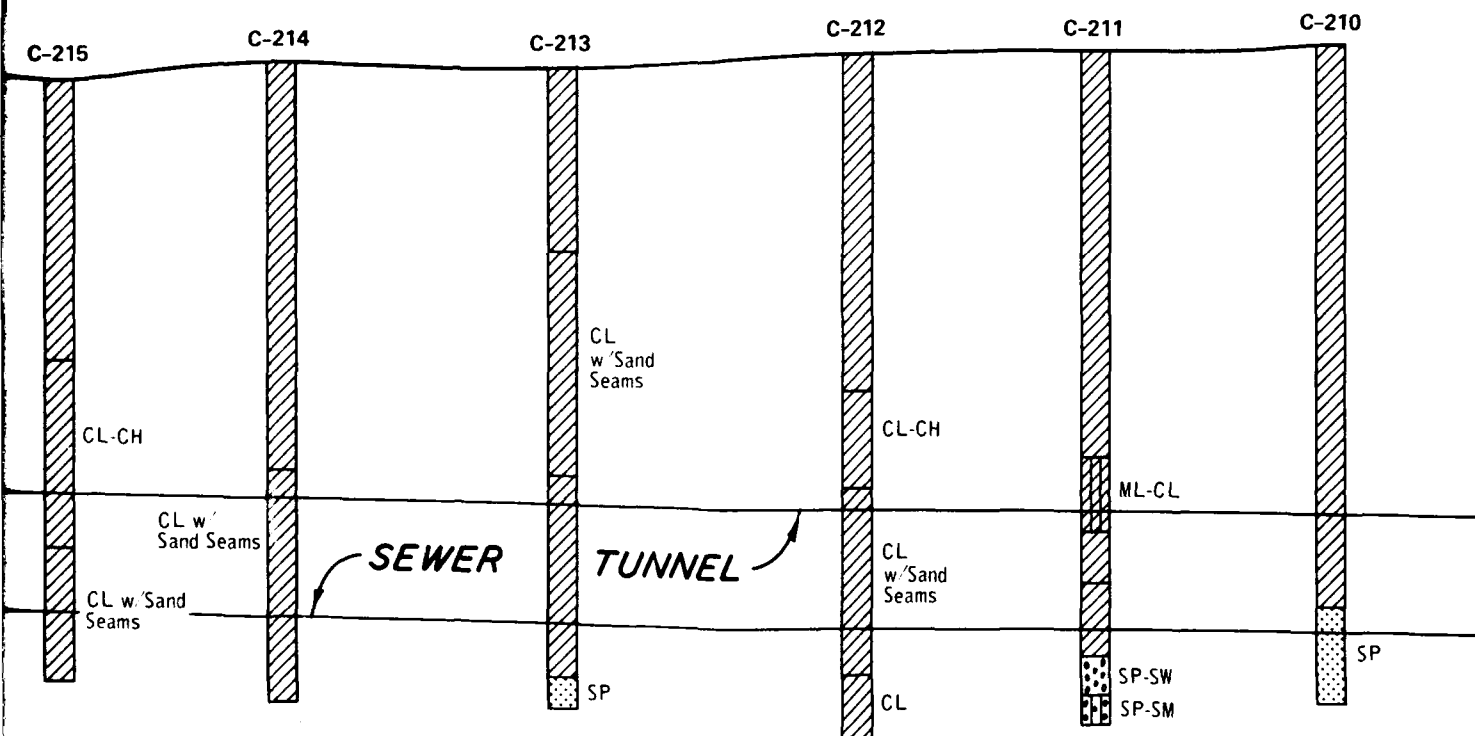
Figure 7. Site geologic profile
15 Mile Road/Edison Corridor
Failure Study

46. Local groundwater. At the site, the glacial sediments consist of about 60 ft of gravelly clays overlying some 30 ft of sorted sands and silts (Figure 7). The sand unit lies on top of glacial till and outwash of an earlier glacial age. This last unit is inferred to extend to a depth of 150 ft where it contacts the Antrim Shale. The sand unit is interpreted as a beach deposit due to its characteristic sorting and large areal extent. This unit is probably interconnected in the subsurface with the large glacial lake sand deposits which are located less than 2000 ft to the southwest (Figure 6). A minor amount of recharge water comes from crossbed leakage from the clay deposits due to the large areal extent of the beach deposit. Some recharge could also be contributed by seepage from the Red Run River at the site. In addition, as indicated by Figure 7, the sand thickens and is coarser

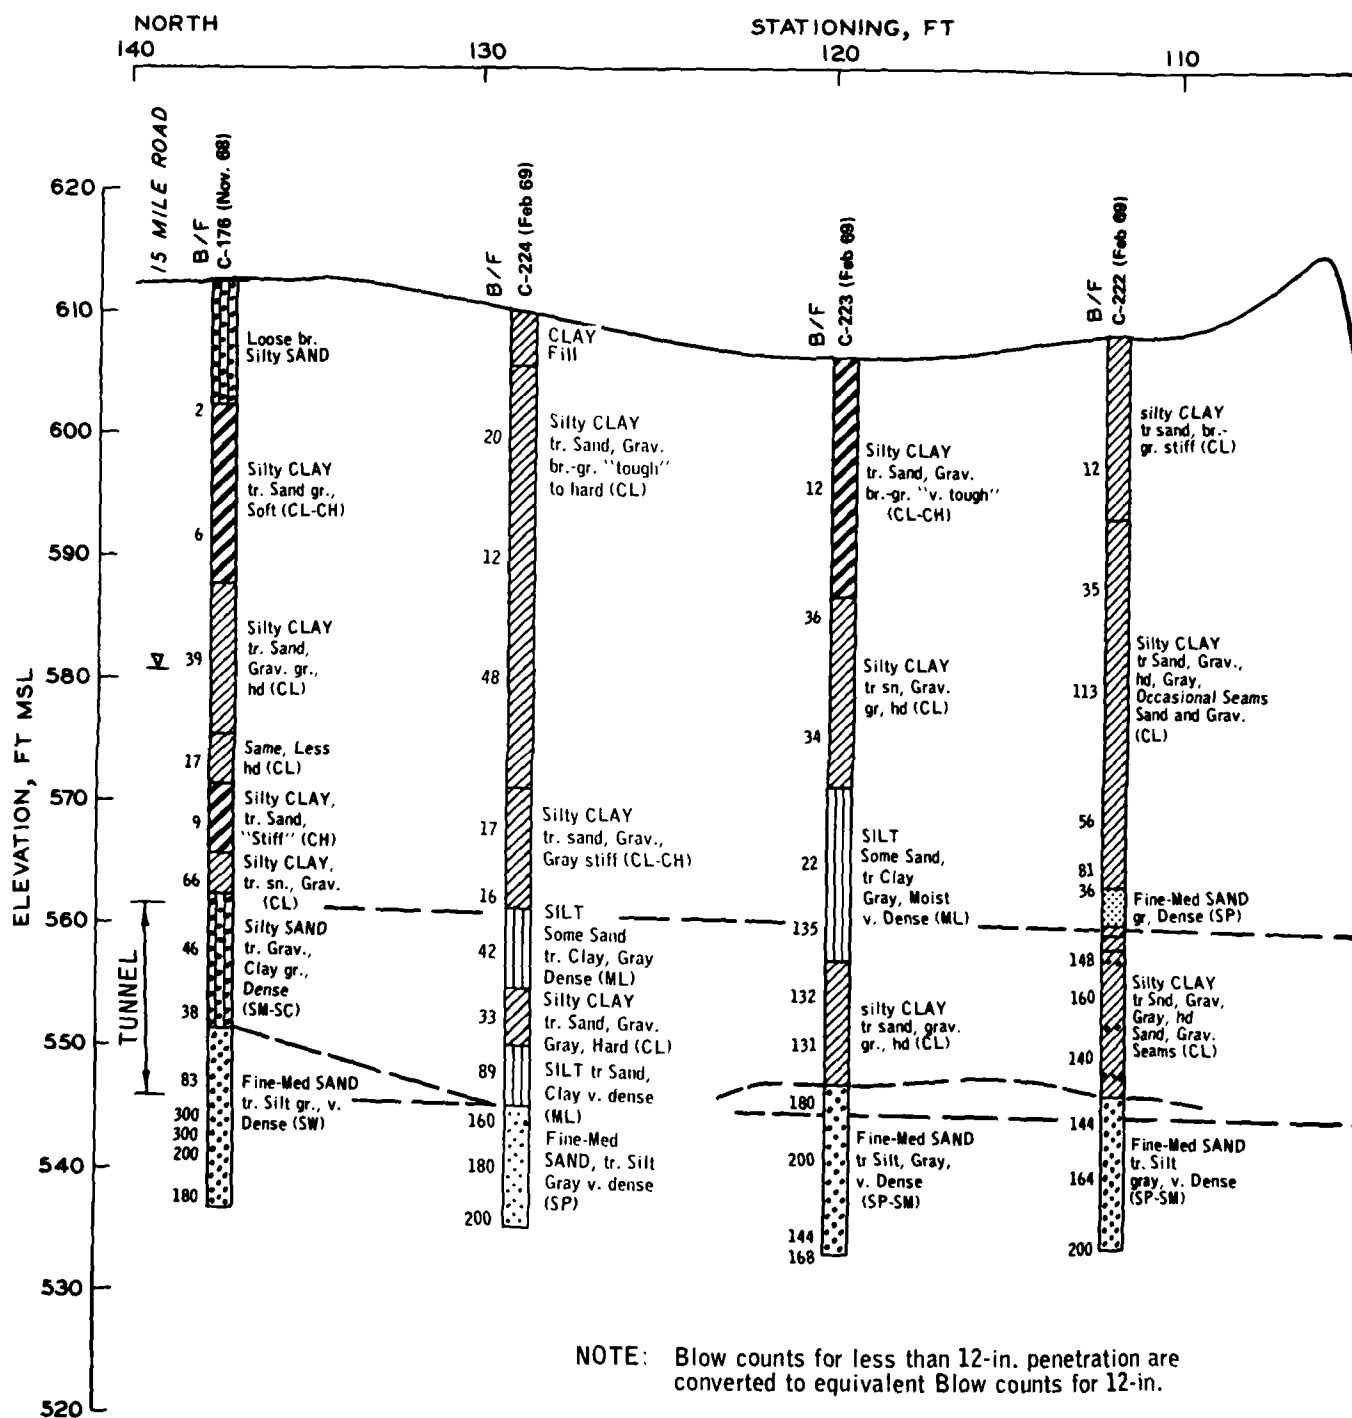
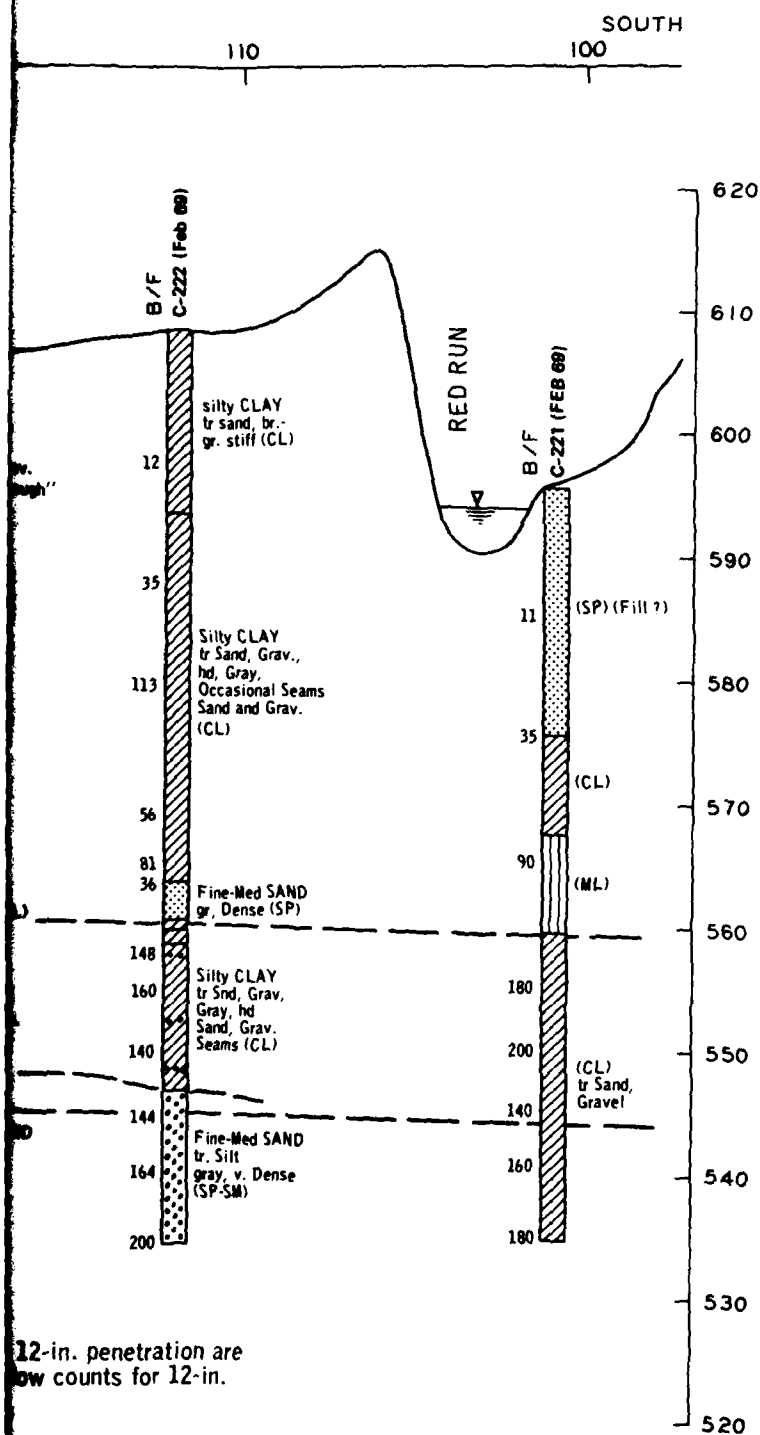
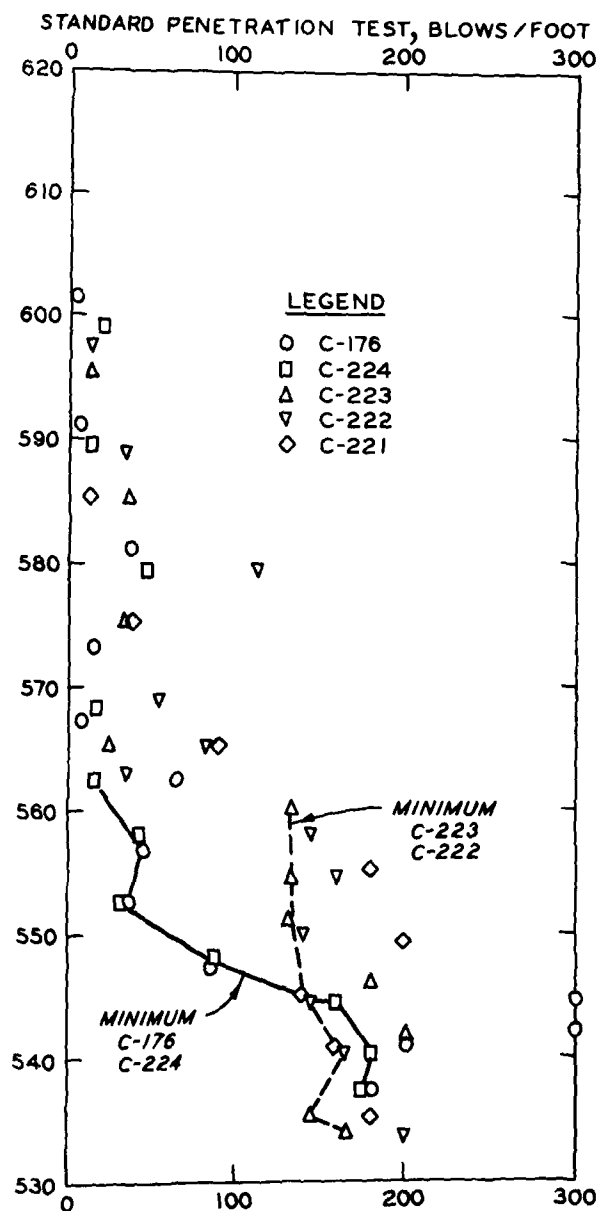
Figure 9. Preconstruction geologic profile, 15 Mile Road/Edison Corridor Tunnel Failure Study

47. Preconstruction boring logs C-176, C-224, C-223, and C-222 cover the tunnel study area from Stas 137 to 112. A profile of these boring logs, shown in Figure 9, indicates variable strata of gray hard silty clays and silts along the tunnel and the top of a strata of very dense, fine to medium sand, along the base of the tunnel. Blow counts increase significantly in sands below elevation 550 to 545 and generally range from 150 to 180 in the sand. Minimum blow counts below elevation 560 are significantly higher in the silty clays and silts in borings C-223 and C-222 than in C-176 and C-224. Although all boring logs indicated only a trace of gravel in the clays and silts above the tunnel, the high blow counts in borings C-224 and C-222 could be the result of higher gravel content.

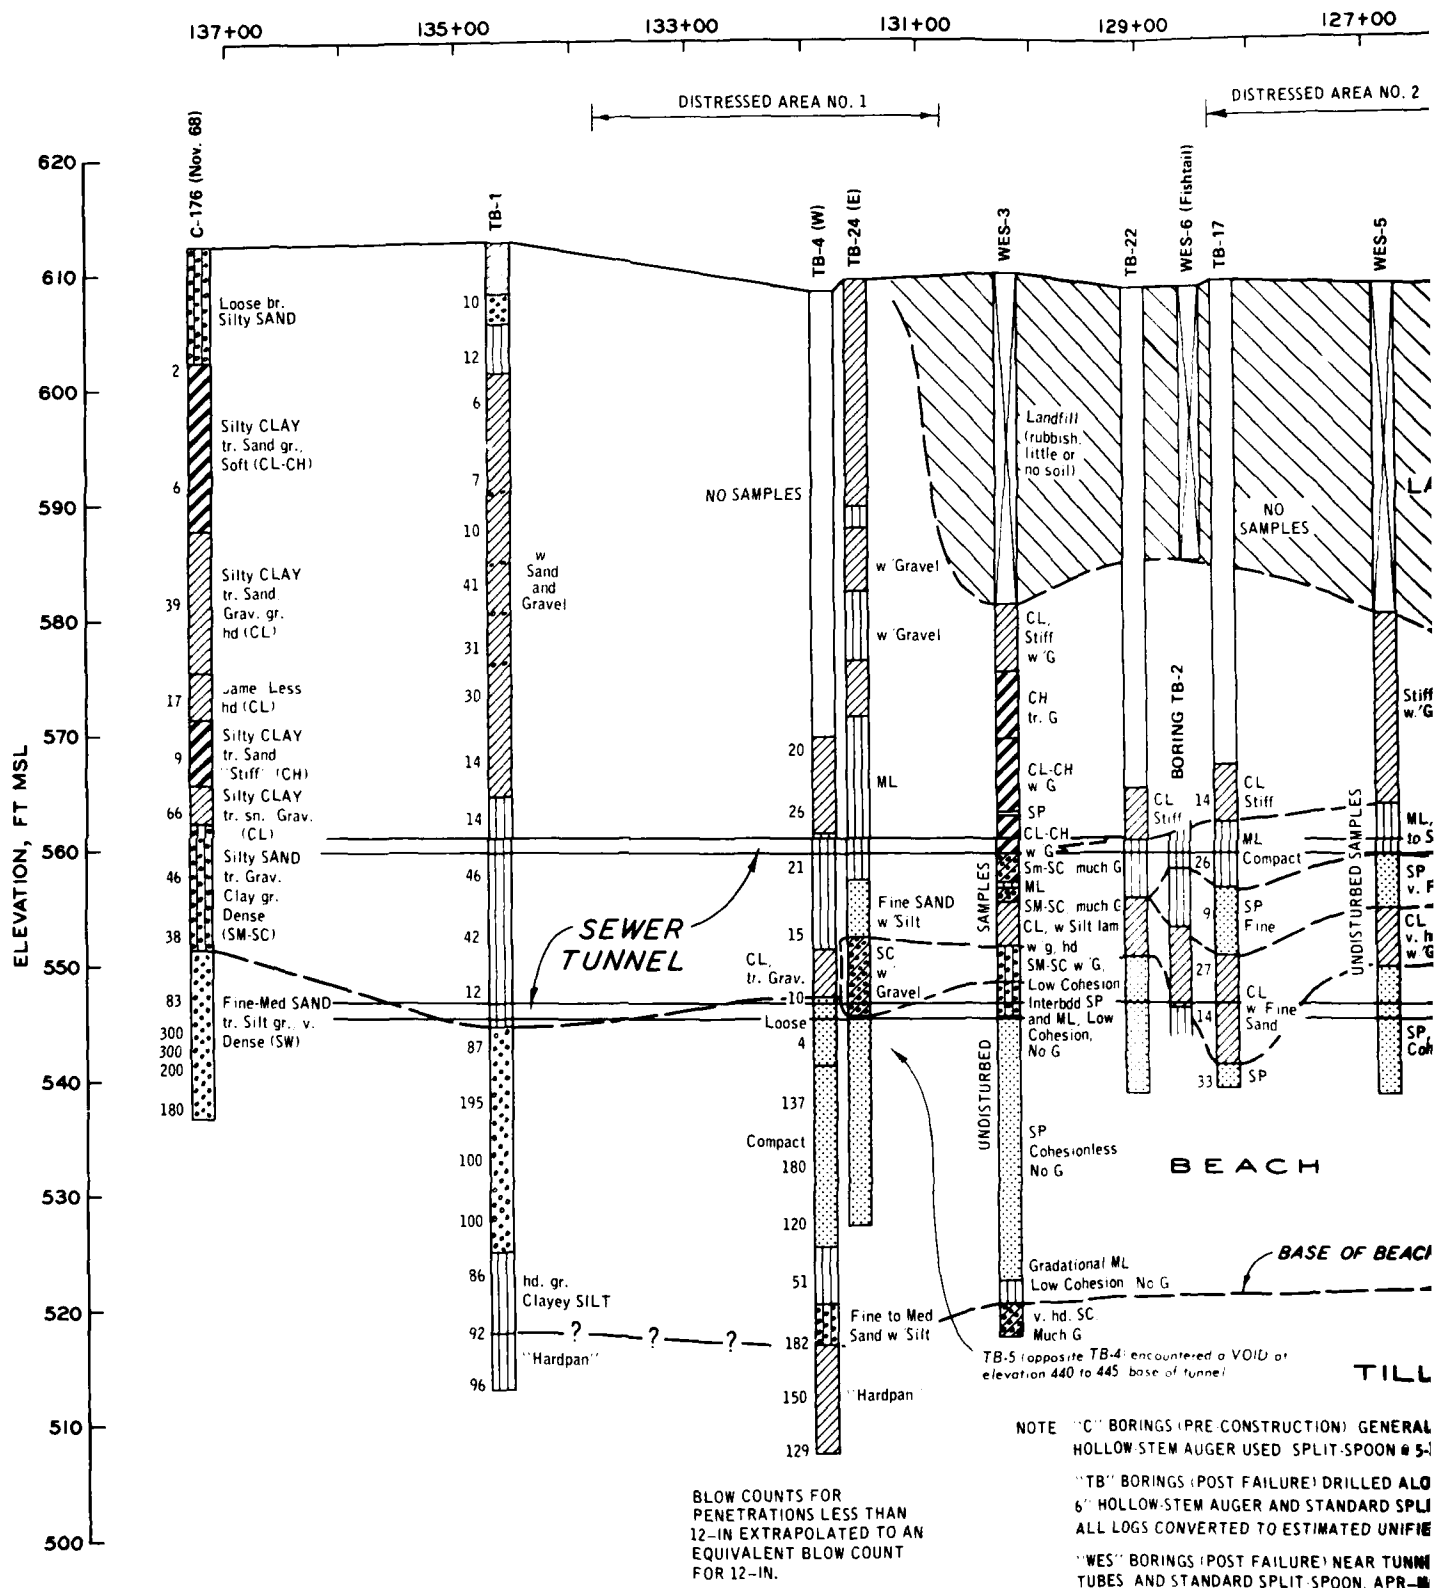
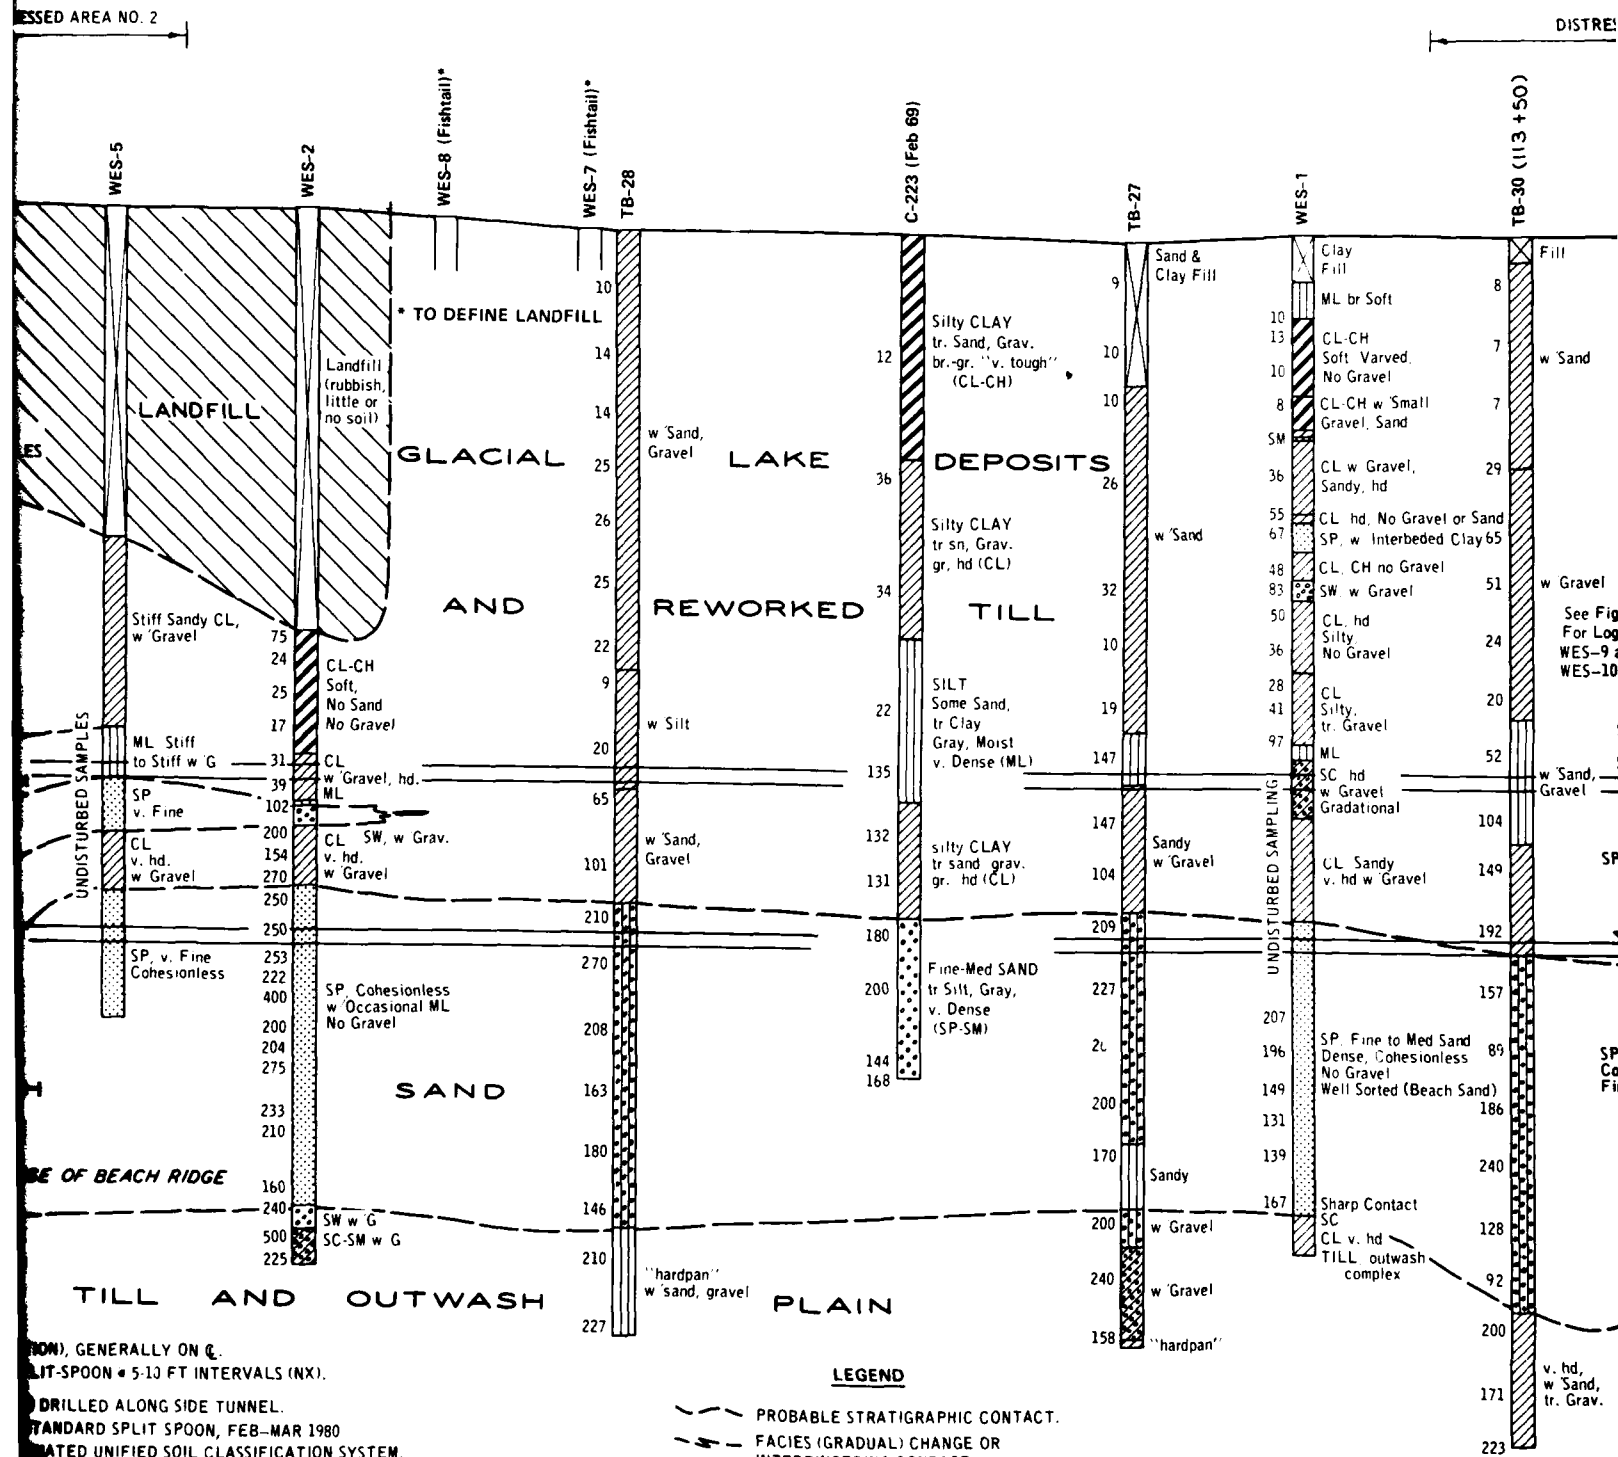
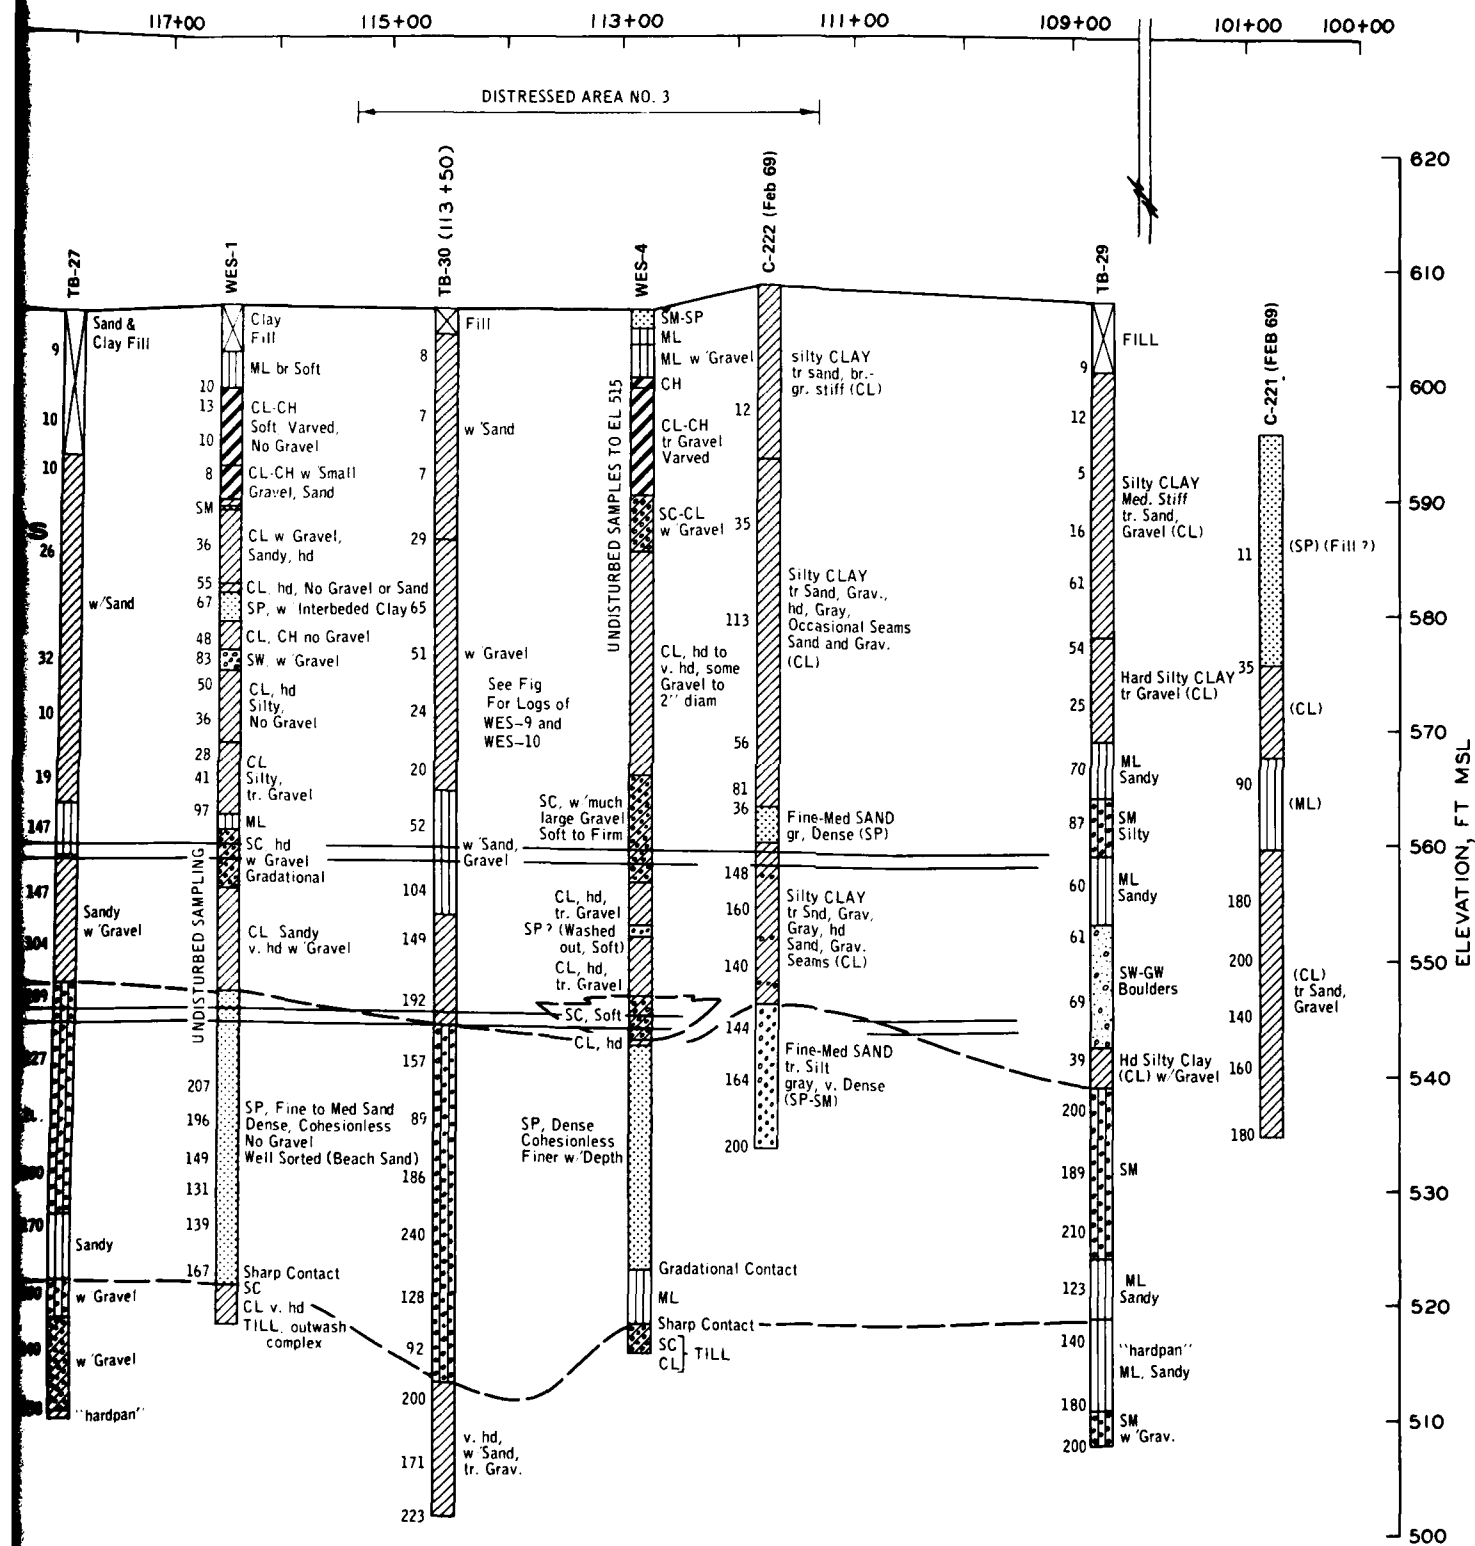
Figure 13. Detailed stratigraphic profile, 15 Mile Road/Edison Corridor Tunnel Failure Study

- a. Landfill dump. The presence of a "sanitary" landfill extending to a maximum depth of about 40 ft was verified in borings WES-2, -3, -5, and -6 (Figure 13). The landfill, believed to have been started in the 1950's and filled in by early 1960, was also noted by the bypass contract foreman at the site, who stated that they encountered loose rubbish with little or no soil when excavating for the temporary bypass east of the tunnel. Boring C-224 (Figure 9), 12 ft west of the centerline, did not encounter the landfill. Several "TB" borings recorded "no sampling" in the upper 40 ft or so of the log and some of them may have indicated the presence of the landfill. However, the WES borings represent the only certain verification of the landfill. The refuse encountered was typical landfill debris with little or no soil content, and included paper products, tin cans, automobile tires, and other rubbish that caved so badly the entire vertical section had to be cased to allow sampling

of the underlying soils. The north-south limits of the landfill are shown on Figure 13 as well as could be determined from borings. Borings WES-7 and -8 did not encounter the fill. The east-west extent of the landfill is not known, but the fill definitely exists just east of the tunnel. The probable significance of the landfill to this investigation is that the excavation replaced 25 to 40 ft of tight clays (low permeability) with loose permeable rubbish that readily fills with water. Such an excavation might also have relieved residual lateral pressures in the soil in the vicinity of Distressed Area 2.

- b. Clay strata. The upper 60 ft of gravelly clays is a complex series of glacial lake sediments. WES borings 1 and 4 logged varved soft clays associated with quiet water glacial lake deposition. Much of the gravelly clay and other lean clay (CL) encountered in the upper 60 ft was resistant to penetration by the sampler (standard split spoon and 140-lb hammer) and a few units were considered very hard, indicating a high degree of consolidation. Some samples from the gravelly clay between 20- and 40-ft depth in boring WES-4 were almost shale-like in consistency and hardness. The silts and sands encountered within the upper 60 ft generally all exhibit some cohesion and maintain their shape when cored. An exception is the 5-ft thick sand lens near elevation 555, Sta 124+00 to 129+00, logged as SP, SW, and SM in several borings, that shows only a little cohesion. Blow counts in borings presented in Figure 13 increased abruptly at similar depths (around 50 ft at elevation 560 msl) south of Sta 125+00. The soils at that depth would appear to have been overconsolidated by loading, but because the sediments down to a depth of about 90 ft have been determined to be late Wisconsin glacial lake deposits (para 38), there should have been no thick glacial ice loading of the upper 90 ft. It is also improbable that any great thickness of soil overburden has been subsequently removed in the short geologic time since deposition of the sediments occurred. The glacial till complex below the beach sand unit (Figure 13) is interpreted as older glacial drift and probably has been ice loaded and overconsolidated.

medium-grained sand to very fine (grit just perceptible) to silt size. The silt sizes generally occur toward the base of the unit, as can be seen in borings TB-29, WES-4, TB-27, WES-3, TB-4, and TB-1, Figure 13. The sand is predominantly quartz with varying percentages of light and dark colored accessory minerals of igneous origin. The top of the beach unit, as determined from boring logs, is relatively flat (less than 5-ft relief) along the tunnel line and is exposed along the tunnel above the invert.

- e. Nondistressed section between Distressed Areas 1 and 2. Between Distressed Areas 1 and 2, the beach sand unit grades from interbedded silt and fine sand to fine sand along the tunnel invert and then dips to elevation 531 (Figure 13, borings WES-3 to TB-17) some 5 ft below the tunnel invert, at the north end of Distressed Area 2. Clay and silt strata occur above the beach sand. The 1 to 1 profiles and sections for closely spaced TB borings (extending 72 ft north of Distressed Area 2) in Figure 17 show gradational but relatively continuous clays, silt, and sand strata, respectively, above the beach sand. The gradation data for strata shown as sand and silty sand in Figure 17 indicates considerable sandy silt lenses. The permeability of three sandy silt samples from TB borings (Figure 17) was 10^{-6} cm/sec and 10^{-5} cm/sec for one sample of silty sand. During excavation (as the tunneling progressed south), soils were noted as hard sandy clay to hard clay with sandy spots, stones and rock. The material changed at Sta 128+76 to sand with traces of clay and pebbles to large stones (Table 7). As shown in Figure 17, some samples of clay above the crown and of sand at the base of the tunnel had low dry densities of 105 to 109 pcf (TB-3, TB-22, and TB-17). Other dry densities in the clay, silt, and sand strata ranged from 111 to 118 pcf and from 122 to 140 pcf in the stiff to
